202 5th Avenue, 1919

202 Fifth Avenue, New York, NY

Built 1918-19

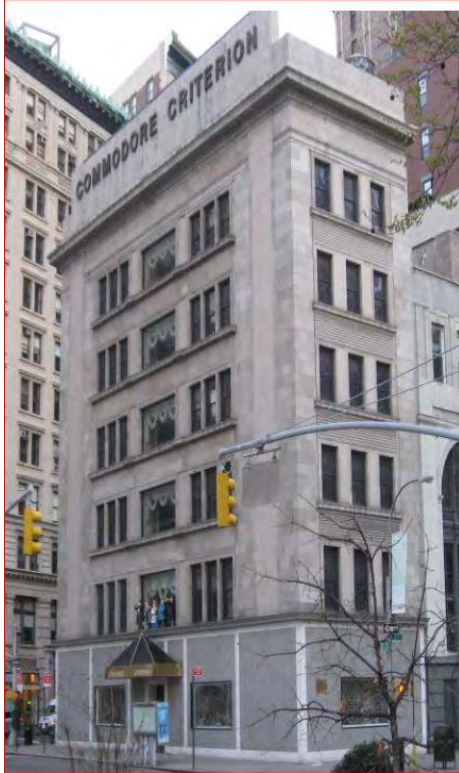
Inappropriate repairs and non-matching coatings are evident prior to restoration
