## Terra Cotta Replacement with Custom System 45 TC Castings

The ability to provide durable, compatible, lightweight, field-castable replacement units is particularly applicable to terra cotta replacement units. The following are several examples of projects utilizing Custom System 45 Type TC for replacement units for terra cotta.

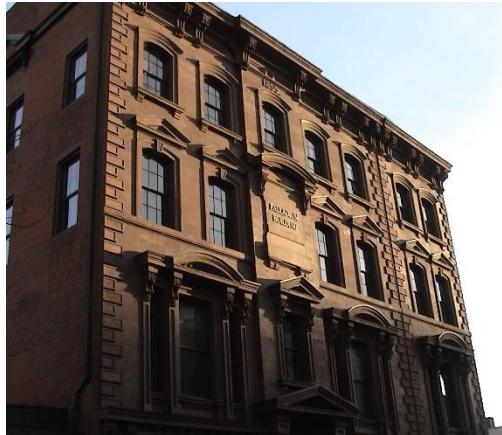
The earliest application, in 1982, involved casting of replacement sandstone details on the 1855 Palladium Building in New Haven, CT, listed on the National Register of Historic Places. Most of the 8 tons of Custom System 45 applied to the façade was used for creation of these cast replacement elements. Thirty-seven years later, the castings remain crisp and undamaged by the many years of harsh New England weather exposure.

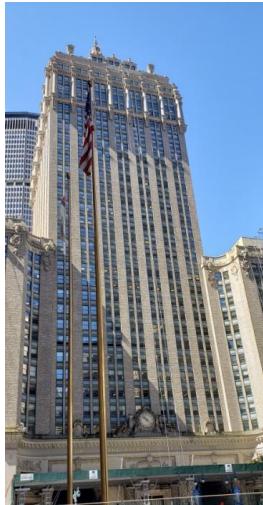
Figure 1. Failed Terra Cotta Bracket, 230 Park Avenue

In 2008, terra cotta brackets supporting massive 3-story terra cotta columns 25 stories above Park Avenue were found to be failing and repairs were undertaken under the direction of Thornton Tomasetti.

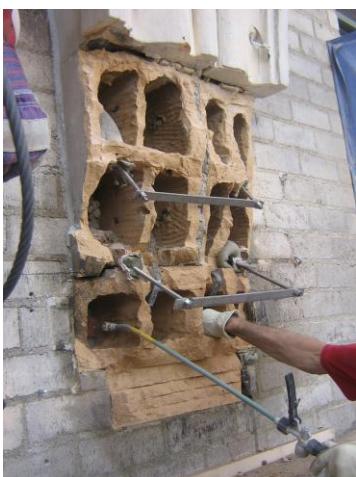
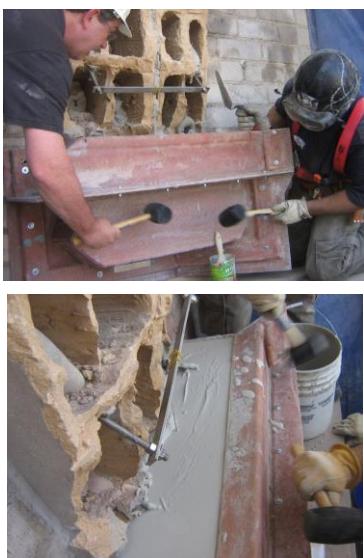
*Photos, left: Following installation of structural anchors, a custom fiberglass mold was attached to the prepared wall surface and Custom System 45 Type TC was poured and consolidated.*

The option to strengthen the existing assembly and to cast new replacement units in place using Custom System 45 TC (Terra Cotta Grade) greatly simplified the process and cut costs by more than 95%. Fiberglass molds were produced and these were re-used to produce replacements for 30 of the 32 brackets on the building.

Individual castings weighed as much as 1000 pounds. The replacements were cast as individual units matching the exact dimensions of the original terra cotta. Existing mortar joints were carried through the work, allowing the building to expand and contract without restriction by the replacement units. After forms were removed, the units were coated with a custom color-matched Elastowall 351 coating, matched to the original glaze color. (Photos courtesy of Jun Yu, Thornton Tomasetti)

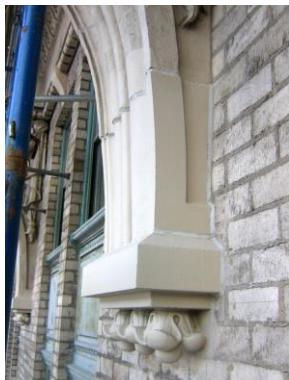
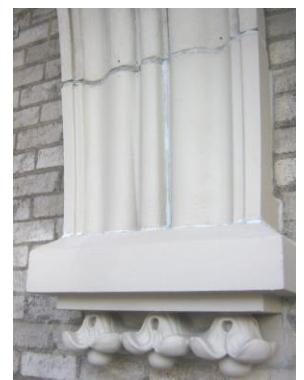
*Photos, Below: Once forms were broken, the castings were coated with Elastowall 351 breathable coating, custom color-matched to the original terra cotta glaze.*

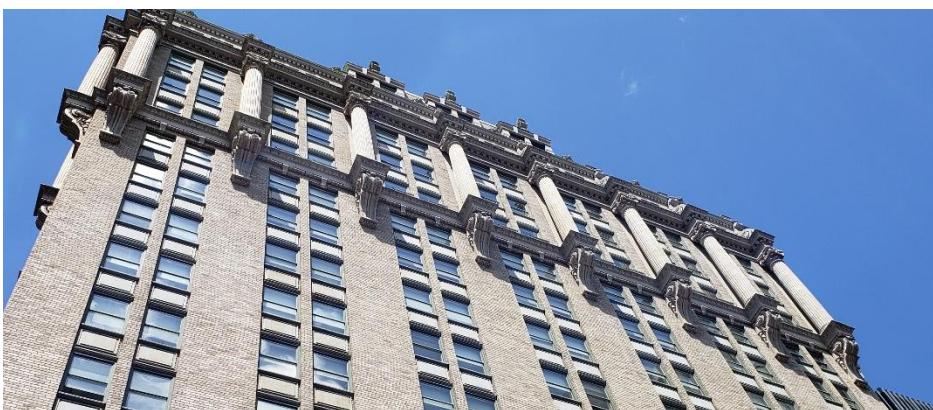
*Photo, left: Eleven years after installation of Custom System 45 castings to replace 30 of the 32 terra cotta brackets on the building which had been damaged, all remain in perfect condition.*

In 2018, follow-up inspections indicated that the castings remain in perfect condition after 10 years. Additional work is being performed in 2019, including repointing with Spec Joint 46 and repairs to stone and terra cotta utilizing Custom System 45.

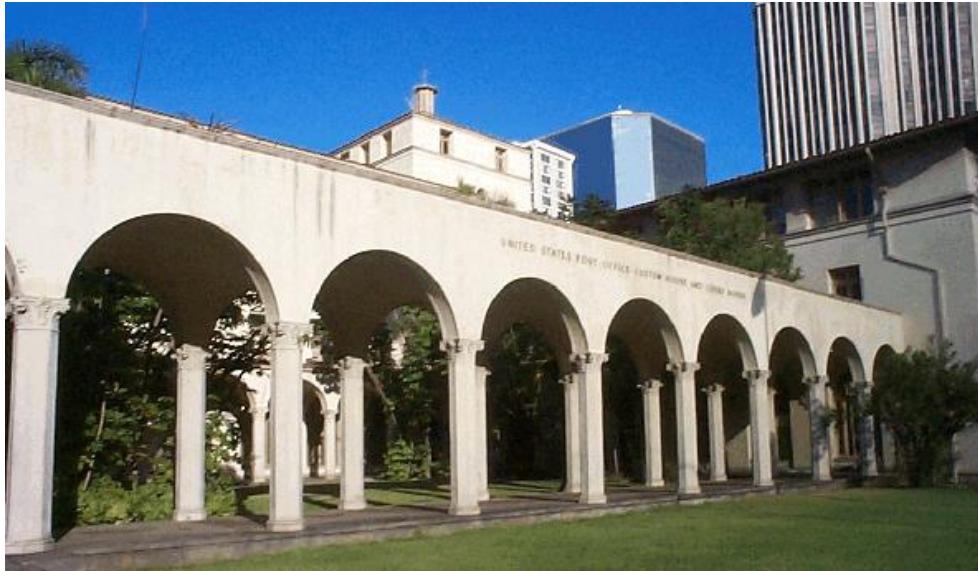
The central courtyard of the US Post Office, Courthouse and Customs House is lined with a series of ornate terra cotta columns.

Shattered terra cotta column sections, shown below, were the result of roof leaks into the columns, containing structural steel that was solidly grouted. Rust-jacking caused various degrees of distress, with the most seriously damaged units requiring replacement. Some units exhibited minor cracking, that could be repaired, while others required disassembly and reassembly after treating the structural steel. Complete roof replacement was also included in the scope of work.

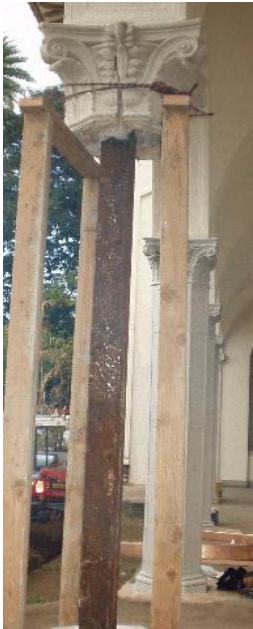
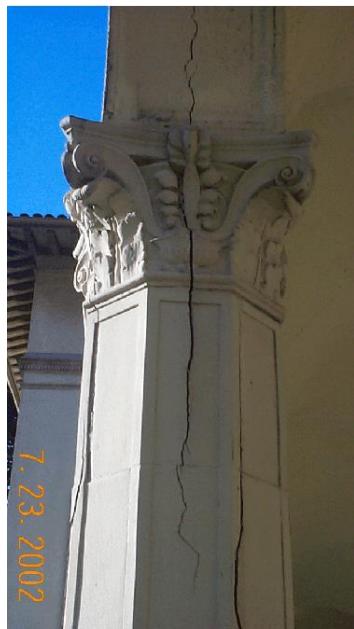
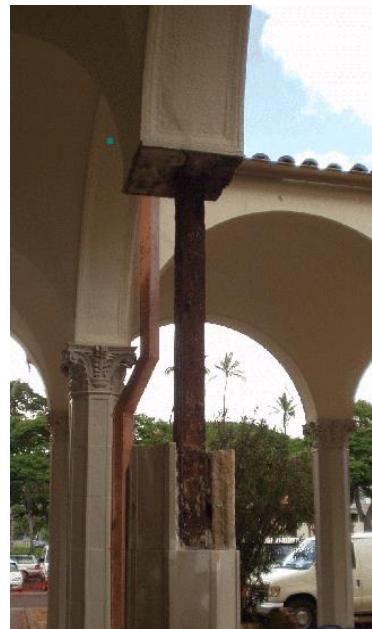
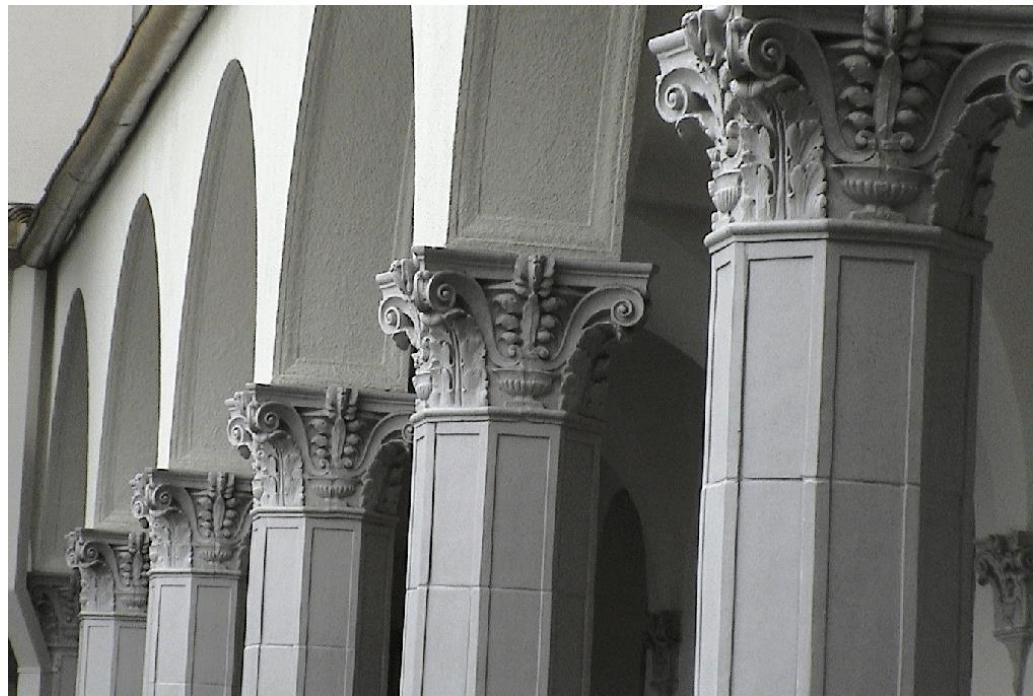
Completed sections of replacement castings are shown above.

As there was inadequate time available to fabricate new terra cotta replacements, Custom System 45 TC with RL-2 liquid component was used to cast new units in 6 different profiles, including 2 sections of ornate column capitals. Molds were made from units remaining in good condition and casting was performed on site, minimizing transportation and handling. It also permitted completion of the project within the scheduled 5-month construction schedule. The replacement units were coated with Aquathane UA210E and Aquaspex 220, matched to the original glaze. They were then assembled as unit

masonry using Spec Joint 46 custom mortar. The project was completed in 2002. When work was completed, the replacement units were visually indistinguishable from adjacent original terra cotta.

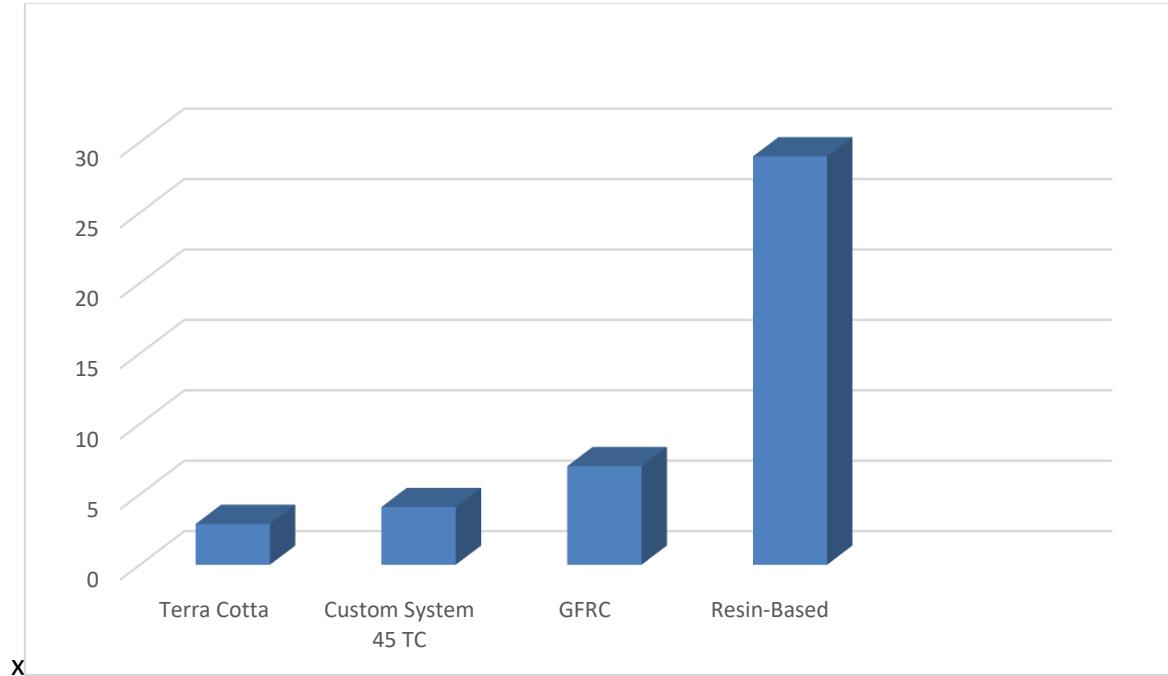
Custom System 45 TC is formulated to closely match the thermal expansion characteristics of terra cotta, assuring that replacement castings work compatibly with existing terra cotta assemblies, even when units are large.

PROPERTY	VALUE	COMMENTS
Linear Coefficient of Thermal Expansion, in/in/ $^{\circ}$ F $\times 10^{-6}$	4.1	Low thermal expansion, compatible with existing terra cotta
Moisture Vapor Transmission, US Perms	2.92	Allows long-term continued drying of wet adjacent terra cotta assemblies
Freeze-Thaw Resistance, ASTM C672	0 Scaling at 50 cycles	Excellent Freeze-Thaw Resistance
Saturation Coefficient, ASTM C67 Part B	0.45	Low saturation coefficient correlates with excellent freeze-thaw resistance
Accelerated Weathering, ASTM G154	No Change, 1500 hours	Complete UV stability and wet-dry cycling stability
